Unpacking inequitable distribution of environmental hazards and amenities
Fiona Macleod CEng FIChemE

BHOPAL – A Case Study

The world's worst industrial accident

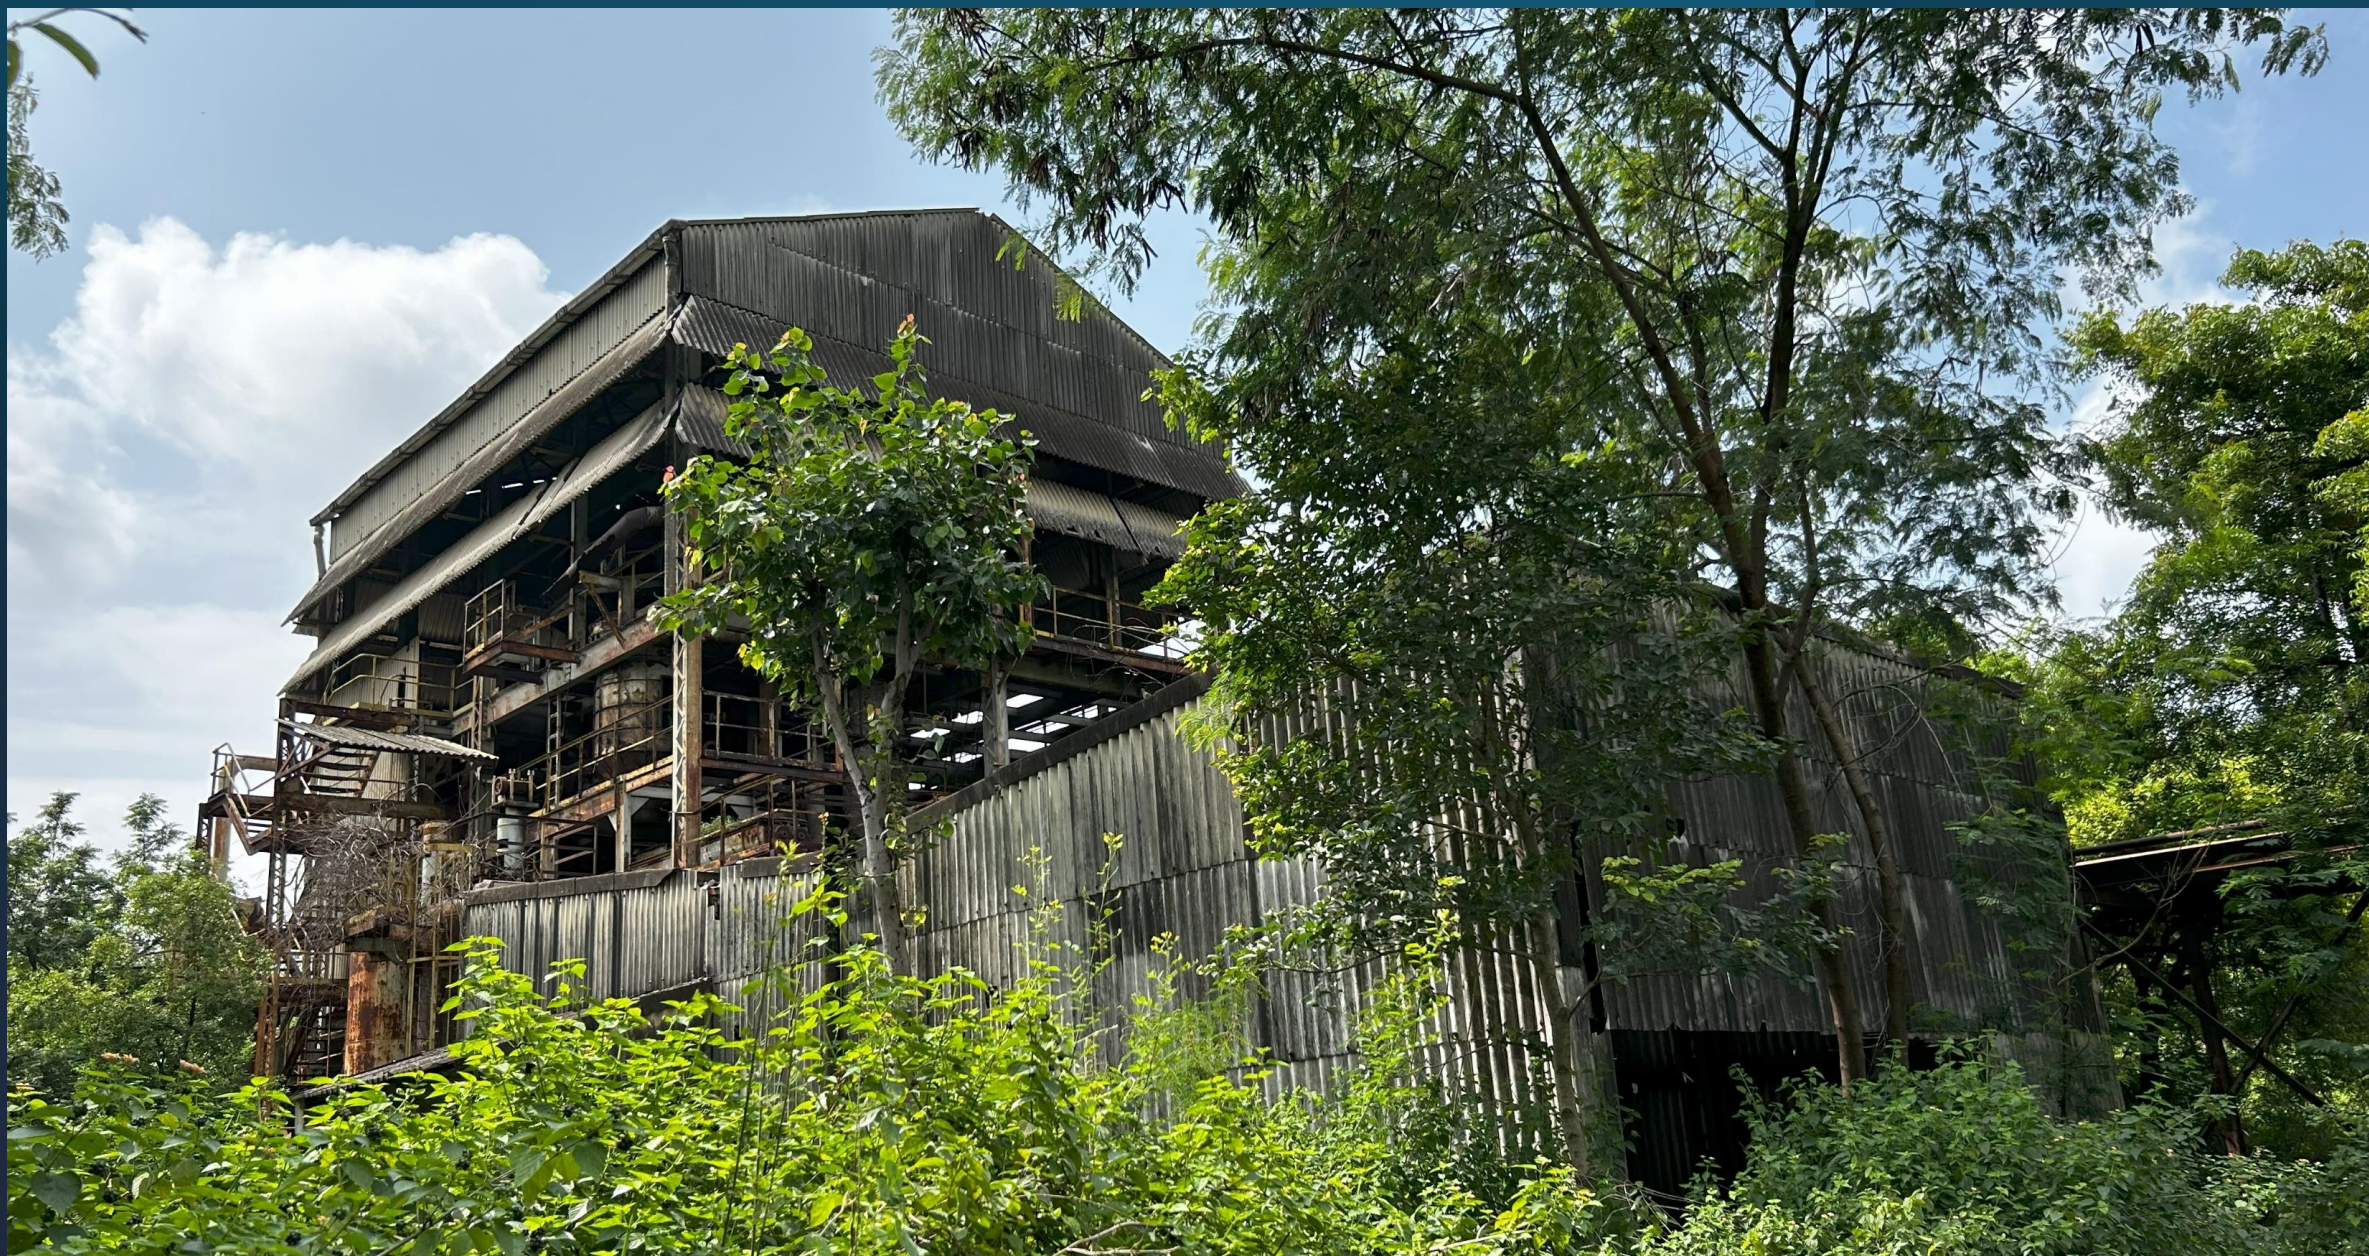
Former UCIL Bhopal factory today

Photo taken August 2023 – @thechemicaldetective www.thechemicaldetective.blog

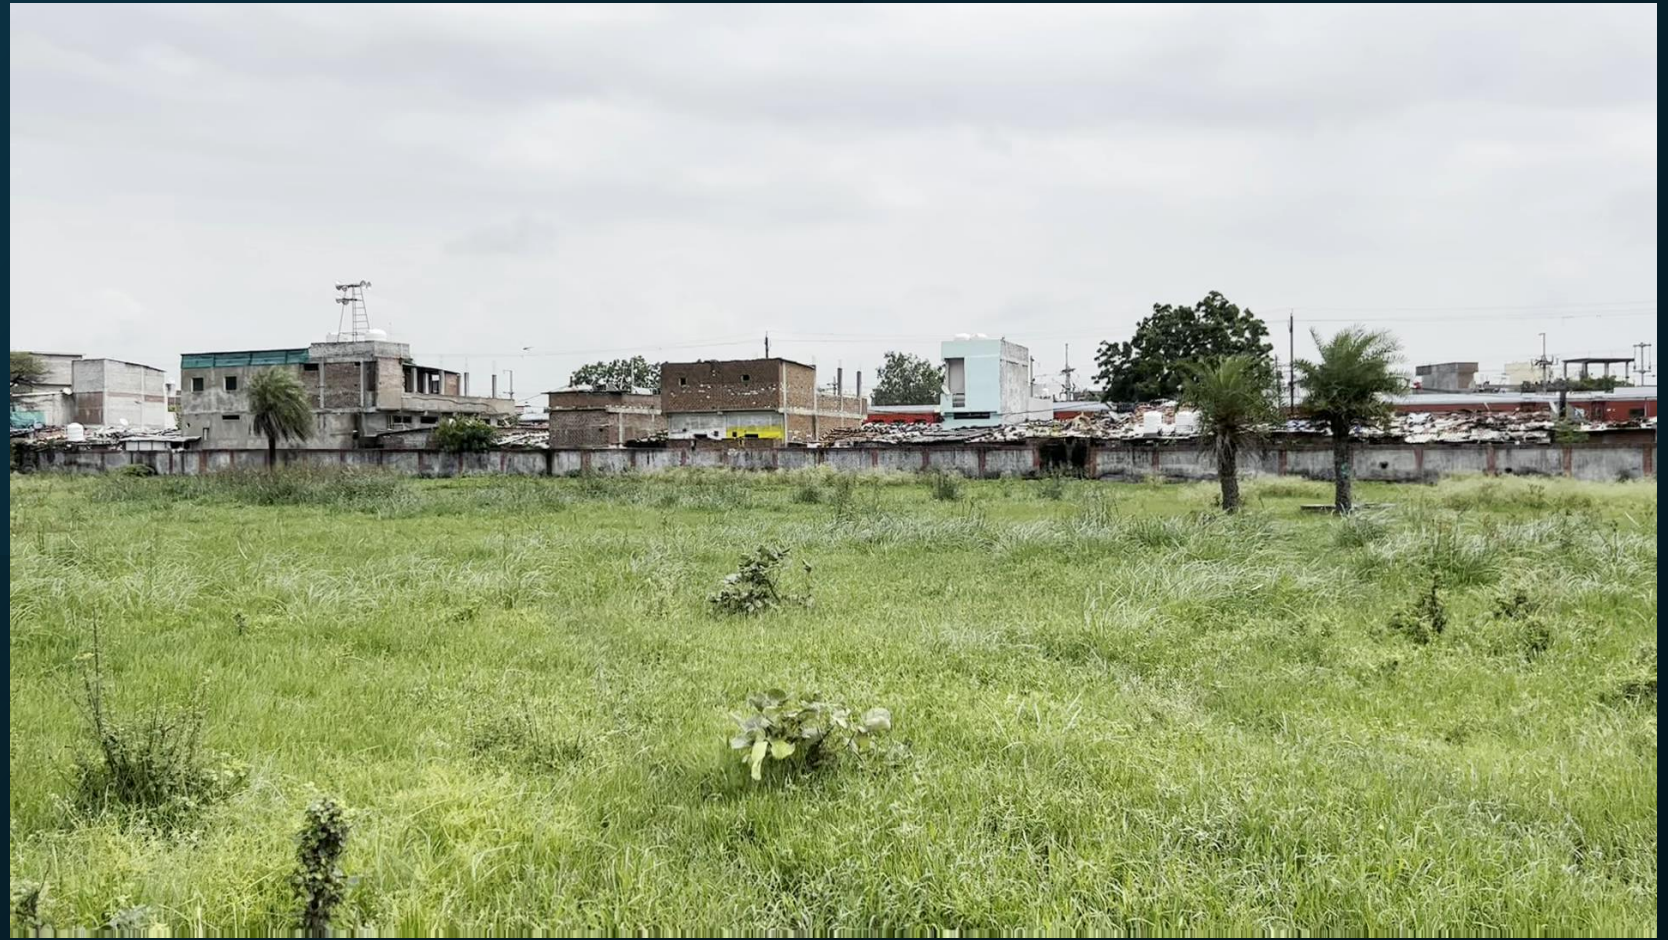
No progress on 2013 plan

Videos taken August 2023
©thechemicaldetective
www.thechemicaldetective.com
