Unpacking inequitable distribution of environmental hazards and amenities
Fiona Macleod CEng FIChemE

BHOPAL – A Case Study

The world's worst industrial accident

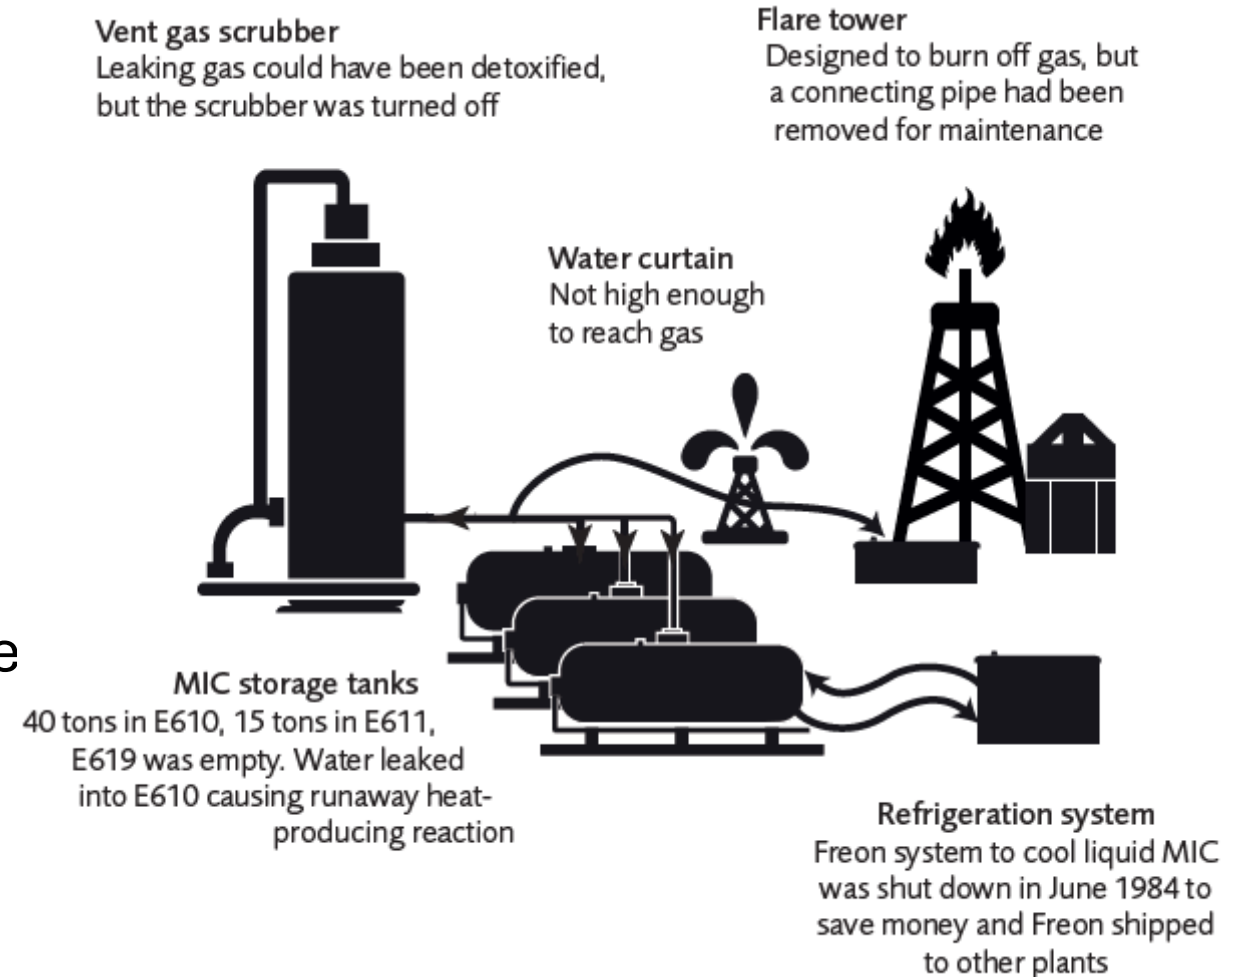
Preparing - Bhopal

- Emergency planning
 - Flare disconnected
 - Vent gas scrubber not in operation
 - Refrigeration decommissioned
 - Water curtain pressure insufficient
 - Public alarm silenced
- Land use planning
 - Growth of communities around site
- Communication
 - Limited

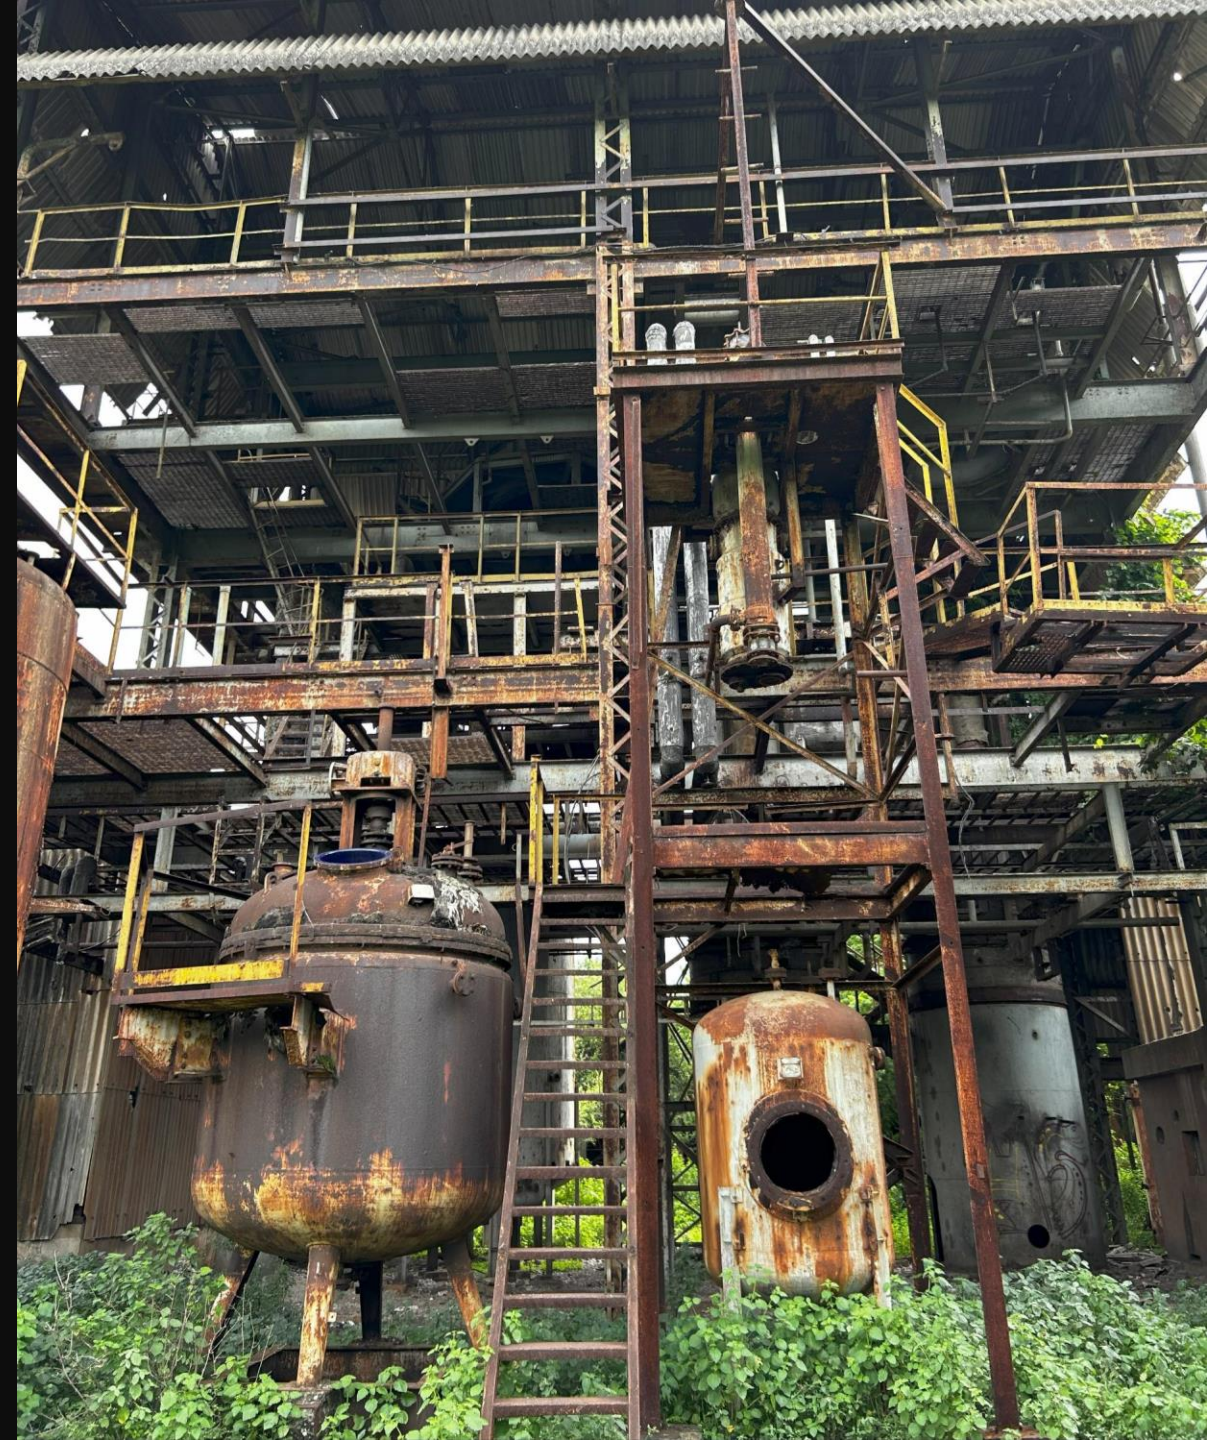
- Chemical plant equipment, piping and structures have been left to corrode and are in an increasingly dangerous state.
- There is no meaningful security - access to the wasteland is open to all, including children and grazing domestic animals.
- There are ~350 tonnes of packaged hazardous waste that need to be contained, stabilised and safely destroyed.
- The soil inside the is contaminated, and ground water pollution continues to spread.
- There has been no effective clean-up of the former UCIL site or the external Solar Evaporation Ponds in Bhopal.
- The surrounding communities continue to suffer.

- Environmental problems at the factory predate the 1984 accident
- A failure to maintain the solar evaporation pond barriers or control hazardous waste has led to heavy contamination of the groundwater in and around the abandoned factory with
 - Heavy metals including mercury, chromium and lead
 - Organochlorides classed as persistent organic pollutants
- Many of the communities affected have still not been provided with a reliable source of clean drinking water
- Domestic animals continue to graze on contaminated land inside and outside of the factory
- The ground water pollution continues to spread.

Timely and effective clean-up

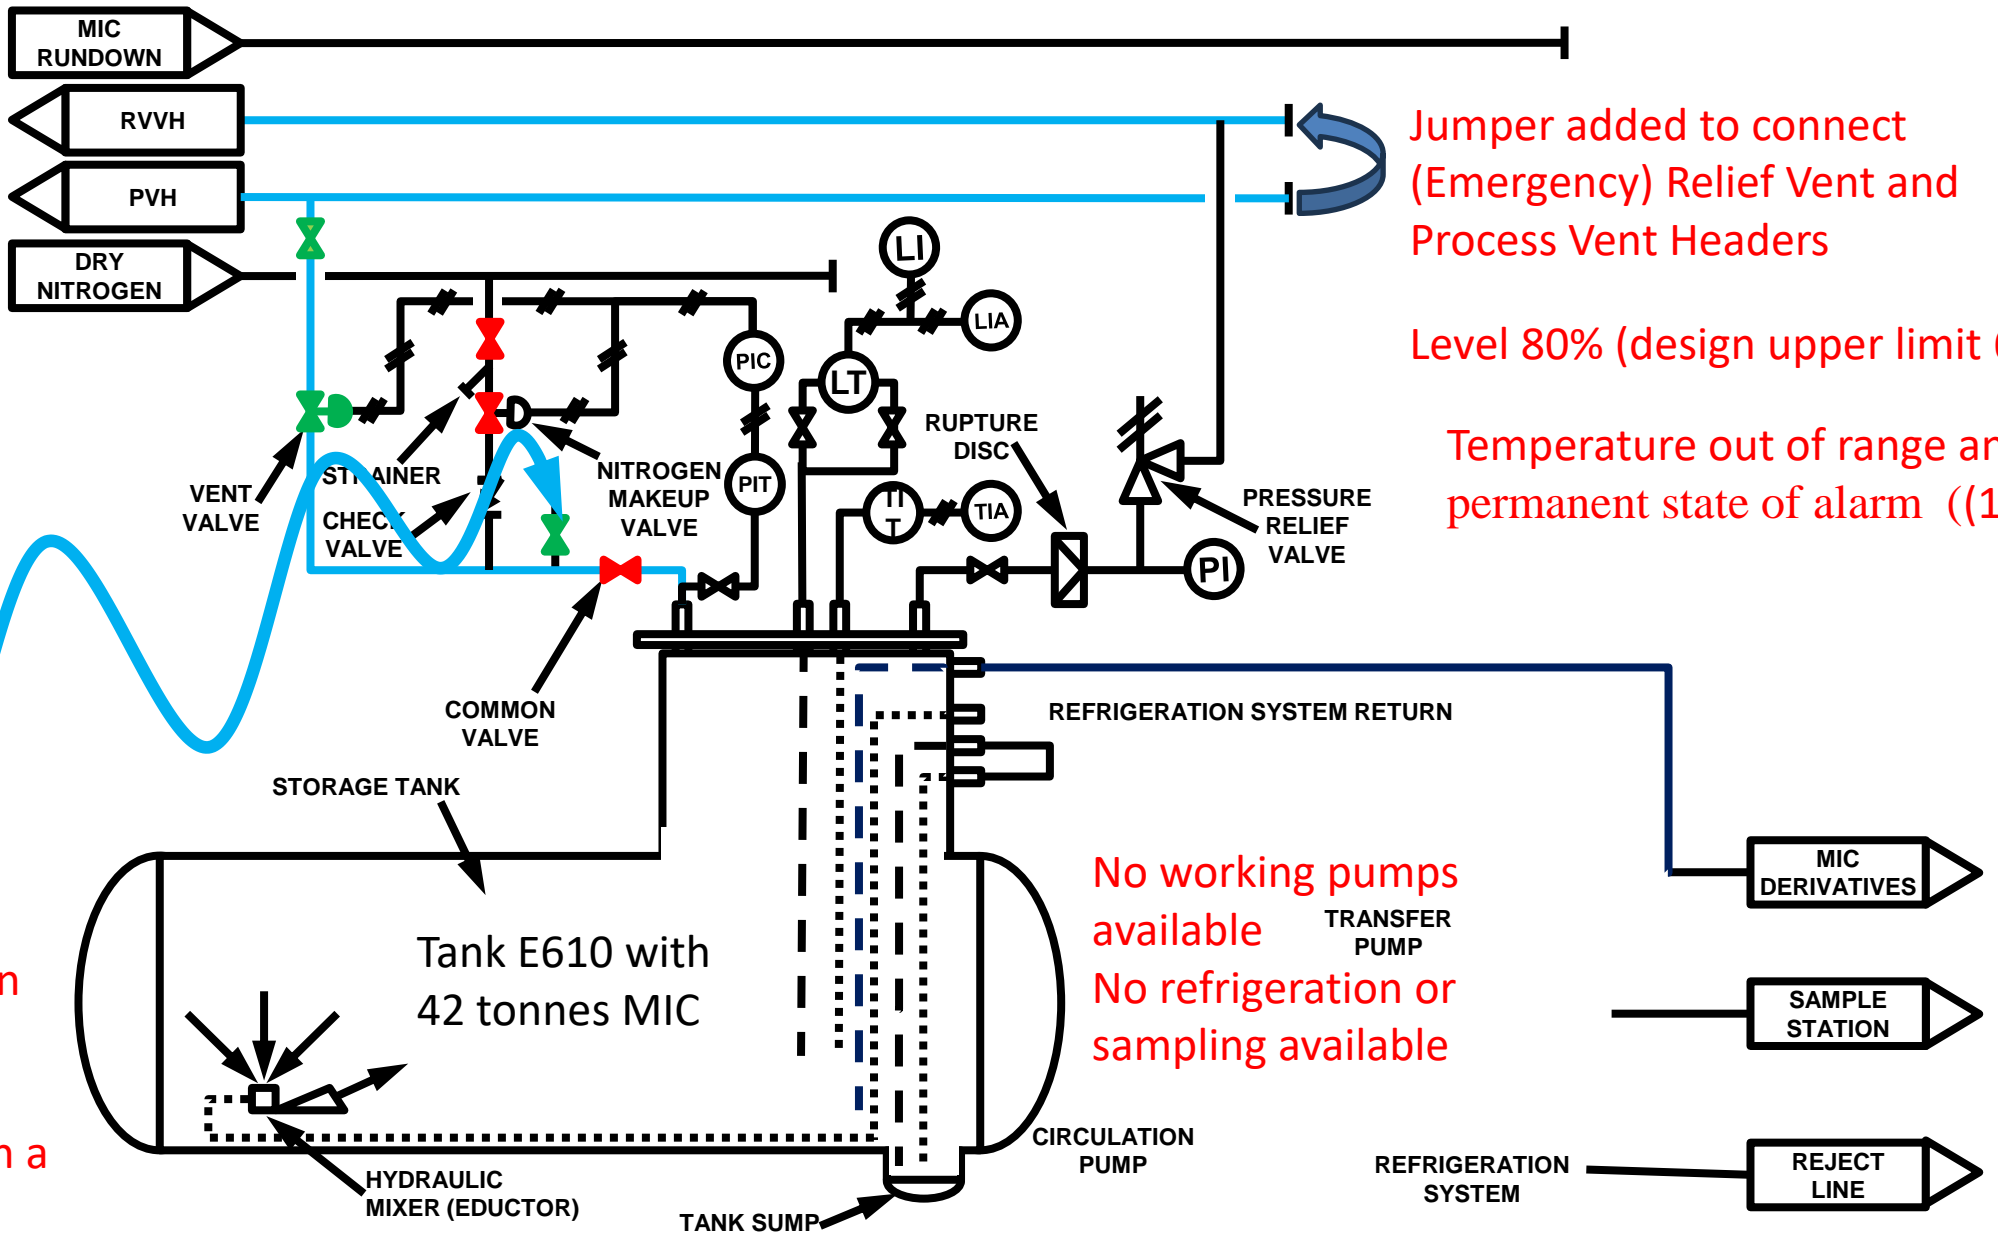
Root Cause Analysis

Misguided attempt to clean vent valve by washing with water relying on a single isolation (common valve)

No working pumps available
No refrigeration or sampling available
